# Transport Aircraft Composite Aging

## AIAA SciTech Forum and Exposition

Allen Fawcett	Boeing Commercial Airplanes
Chantal Fualdes	Airbus
Patrick Enjuto	Boeing Commercial Airplanes
D.M. Hoyt	NSE Composites
Larry Ilcewicz	Federal Aviation Administration

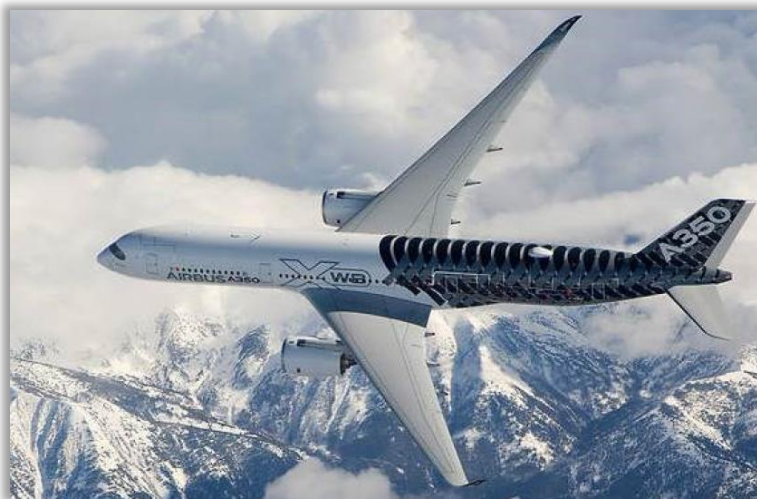
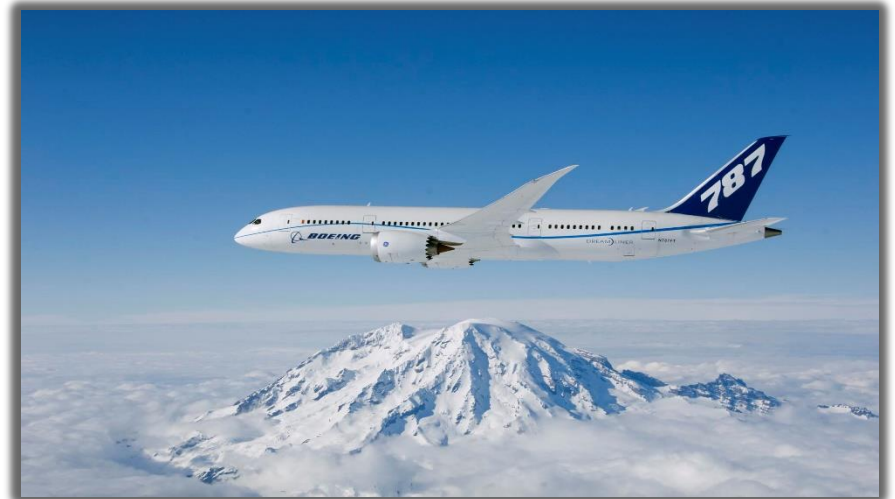
**Over the past four decades, the use of composite materials in commercial aircraft structures has been continuously increasing.**

- Initial use of composite materials in secondary structure accounted for about 5% of the structural weight and, with the addition of empennage structure, 10% of the structural weight.
- Introduction into both wing and fuselage structure has resulted in composite materials accounting for a structural weight percentage approaching 55%.

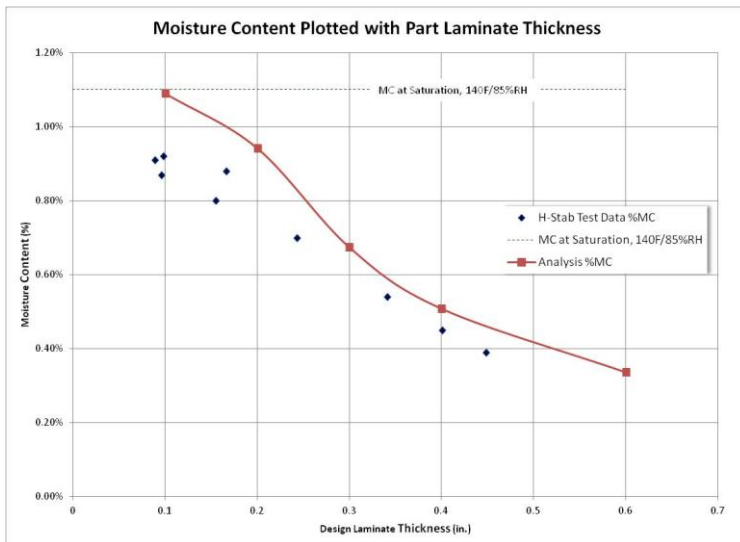
Chart shows moisture uptake for different thicknesses with a typical flight profile over the life of the airframe

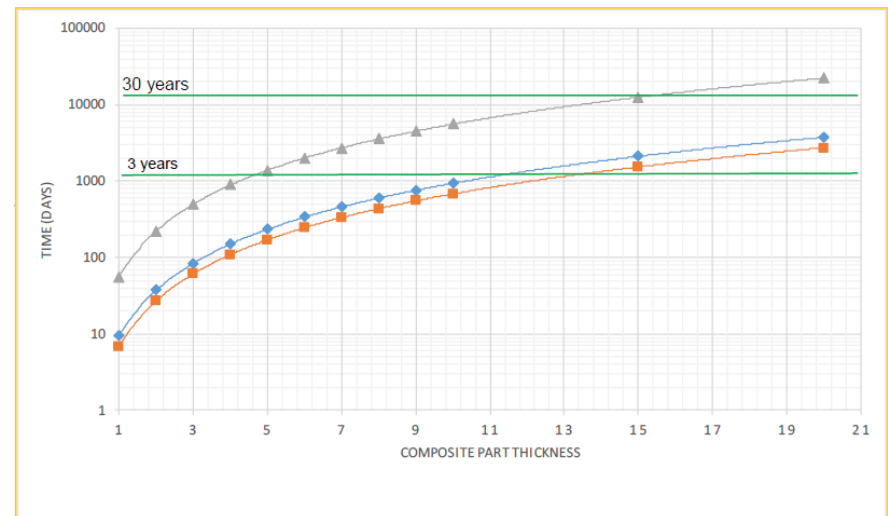
Extrapolation for necessary time (30 years) to achieve 99.9% at equilibrium level (here 1%) for a defined humidity level (here 85% RH) at several service temperatures (23°C, 70°C, 80°C)

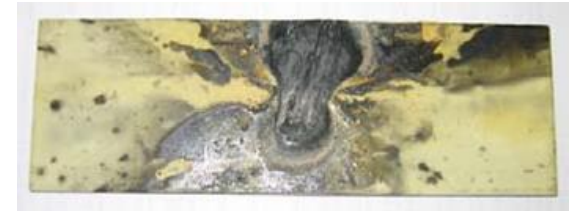
Thermal Envelope for reference standard fabrication:

- Temperature Range: 325 - 700 °F
- Exposure Duration: 5 minutes to 1 hour

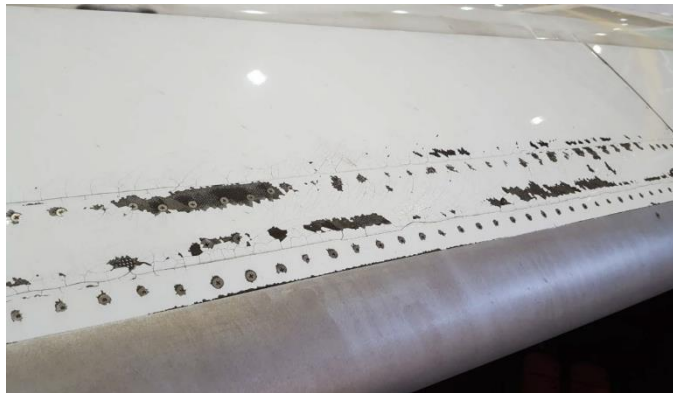
Thick Filler Cracking due to thermal cycling

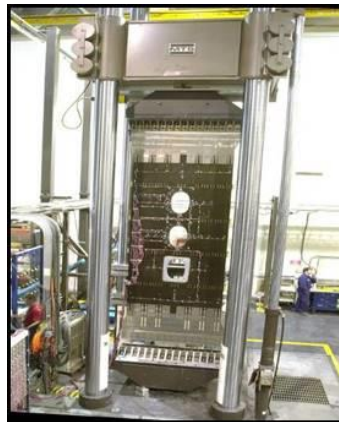
PANEL #

**The effects of accidental damage are evaluated at higher testing levels.**

- Most of the emphasis in composite structural impact and residual strength testing to date has focused on impact criteria established for design purposes.
- The most structurally efficient approach derived from such efforts is semi-empirical, starting at the subcomponent test level.

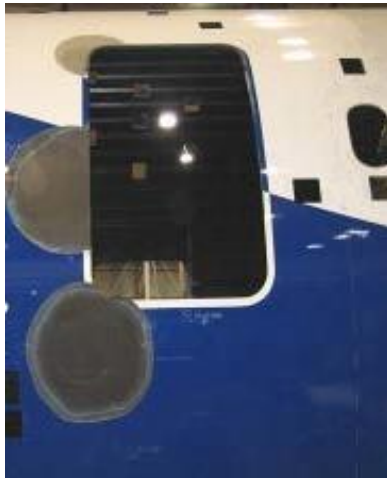
Component test article with SRM-type repairs

Approach Validated by Full-Scale Demonstration

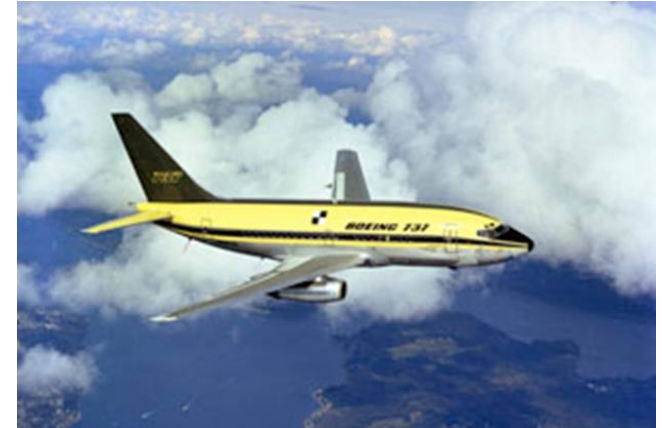
- Sandwich structure
- 108 Spoilers – cumulative over 2 million flight hours and 3 million landings.
- Moisture content less than 1.1%
- No appreciable strength loss.

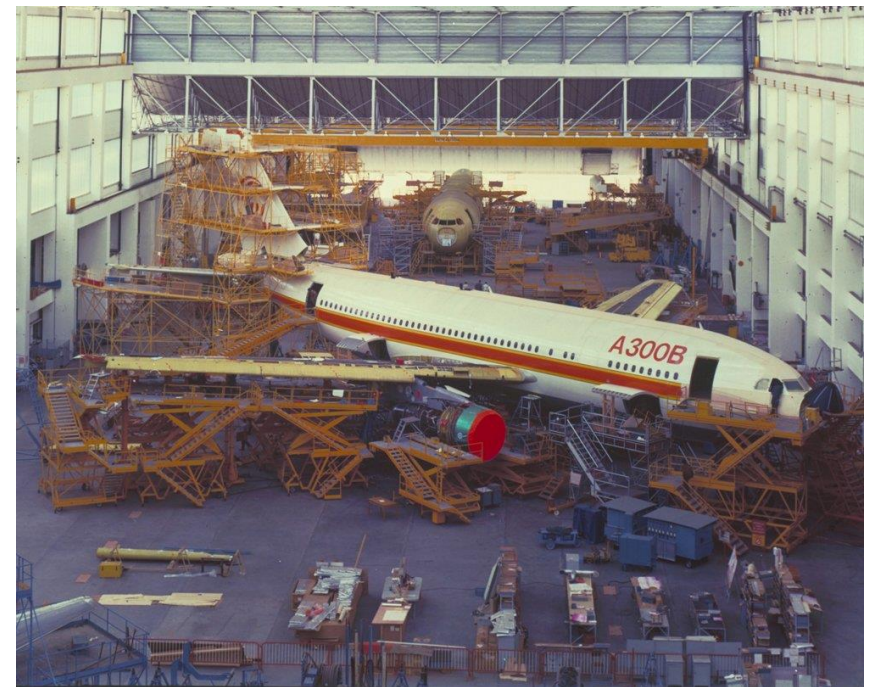
- Sandwich structure
- Five Airbrakes tested to rupture showing no appreciable change compared to the strength level demonstrated initially after 5 to 17 years of real flight.
- No noticeable degradation in material characteristics. Max moisture content of 0.9% was below values using accelerated aging (85%RH, 70°C).
- No growth of damage was found during this campaign.

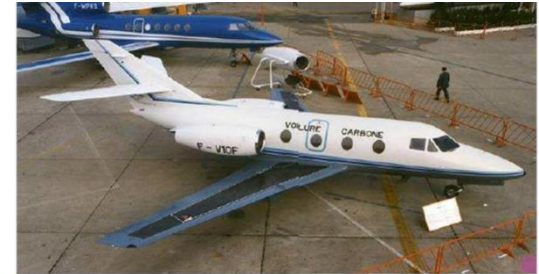
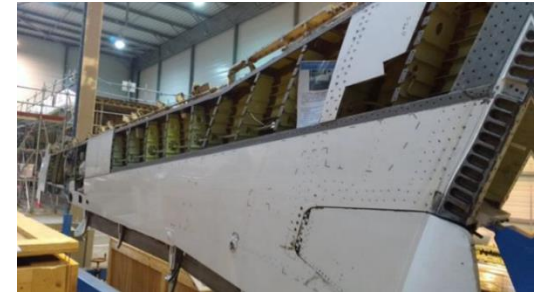
# V10F and ATR 72 Wings

**V10F**      **10,000 Flight Hours**

**ATR 72**      **1,000 Flight Cycles**

- Solid laminate
- Normal evolution of the  $T_g$  as a function of humidity.
- Maximum moisture content below the amount used for accelerated aging in certifying the airplane (1.0% vs. 1.3%).
- No detrimental effects from any damage accumulated on the aircraft.

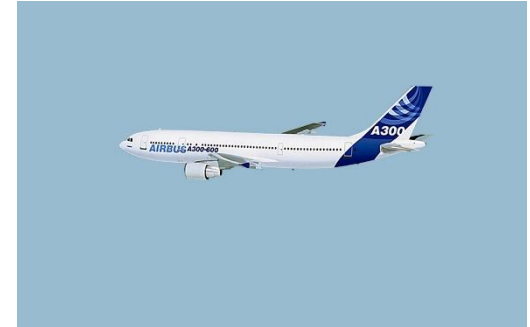
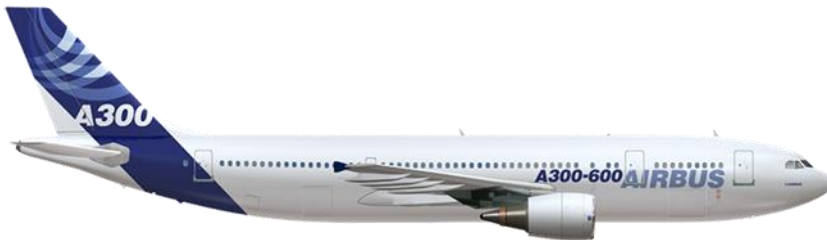
# Airbus A300-600 Vertical Stabilizer

Extracted from the fleet with more than 15 years of service

- Solid laminate
- No strength deterioration in high loaded introduction area (lug test) after aging, repetitive loading and high peak loads.
- Demonstrated same strength level achieved at Type Certification.

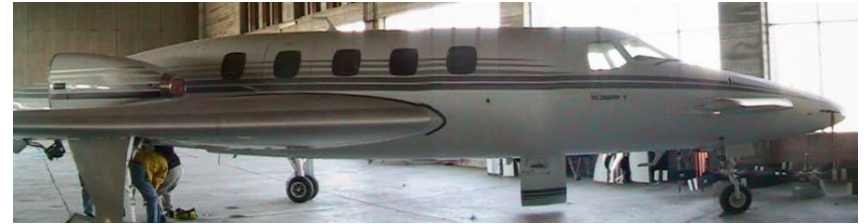
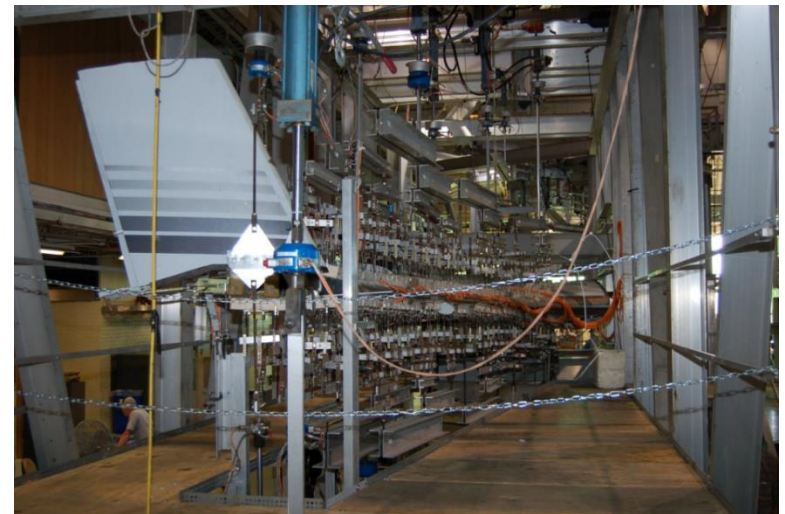
- Structure showed no detrimental signs of aging to the naked eye.
- No evidence of degradation in the thermal properties and fully cured/cross-linked.
- Structure had reached moisture equilibrium (Max 1.1-1.3%).
- Porosity levels correlate with OEM production information.
- Full-scale test results of the aged wing correlated well with the results obtained for the certification article.

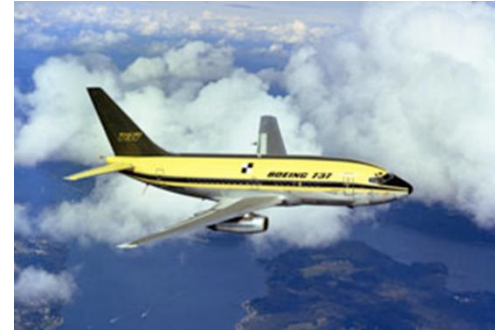
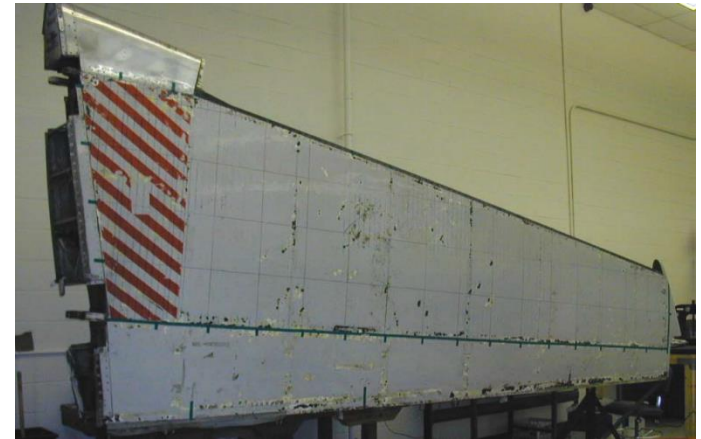
- Solid laminate panels and spars, sandwich ribs.
- No obvious signs of aging to the naked eye.
- Moisture levels in the structure as predicted during the design phase.
- No evidence of degradation in properties and 95% cured/cross-linked.
- Residual strengths met or exceeded the baseline values.

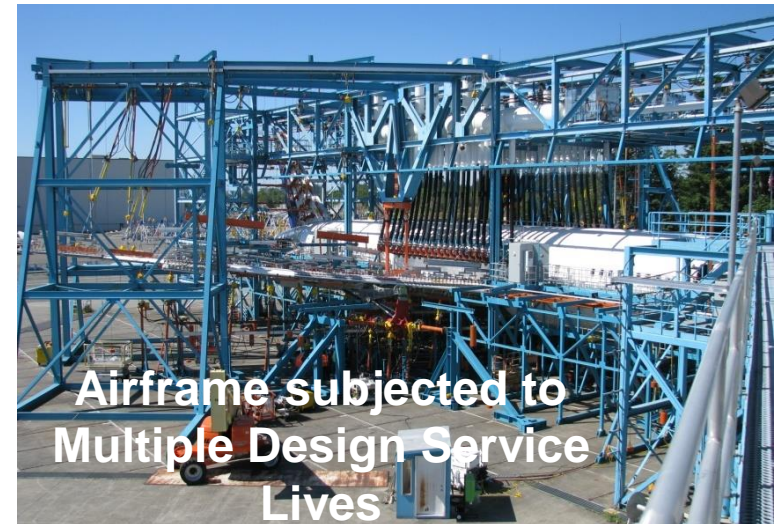
When sizing to static loads and considering joints, repairs and damage threats, fatigue concerns from in-plane loads are not typically a concern.

Resin dominated failure modes and sustained out of plane stresses are properly addressed in the airplane design

Demonstrated suitability of engineering approach for cyclic loading

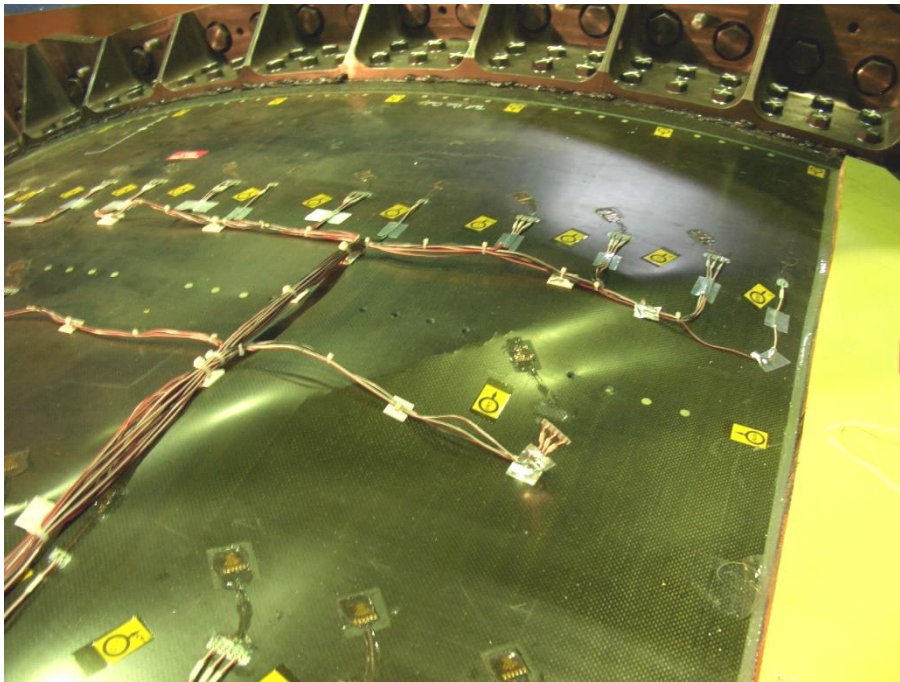
## Development of accidental damage modelling principles for residual strength

- Largely established by test up to large scale level.
- Complex phenomenon (geometry/scale effect) on top of interactions with loading conditions including buckling.
